**Project:** Vulcan Materials Quarry

**Location:** Stafford, VA

**Project Profile**

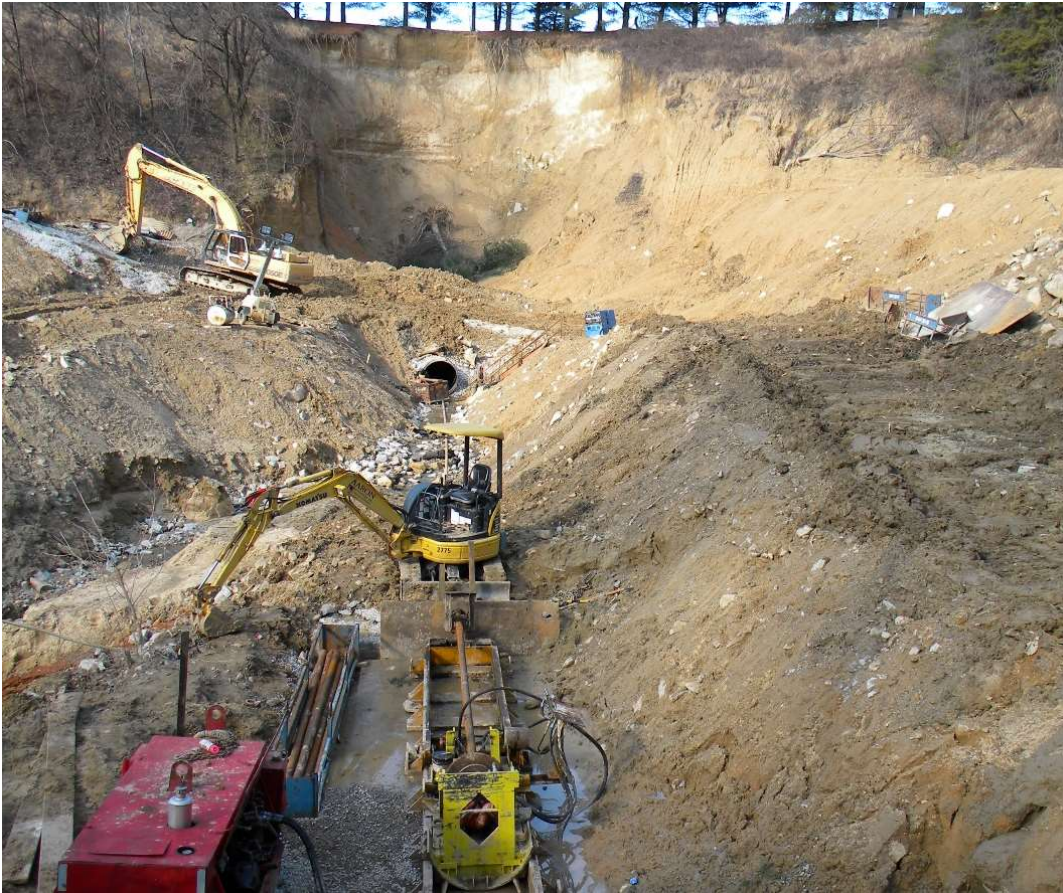
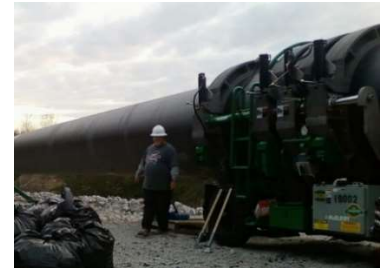
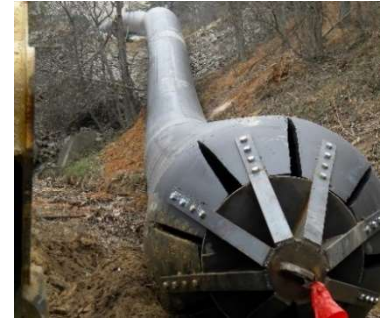
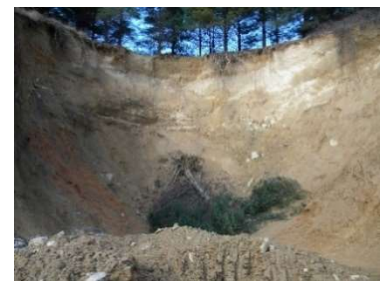
Aaron Enterprises, Inc. was contracted to complete a design build emergency repair of an 800' section of 72" corrugated metal storm water culvert. Erosion caused the hillside above the pipe to give way leaving an 85' cliff and 800' of pipe collapsed. Aaron Enterprises, Inc. proposed hand tunneling a 66" steel casing into place and slip lining it with 63" HDPE to complete the repair. The 72" corrugated metal pipe was intersected by the 78" casing with no alignment issues. The 63" HDPE was then pulled into place in one continuous section.

**Final Product:** 78" steel casing, 63" HDPE carrier pipe
